CHALLENGE:

Contaminants and lack of lubrication

SOLUTION:

Diamond Series O-Ring Chain

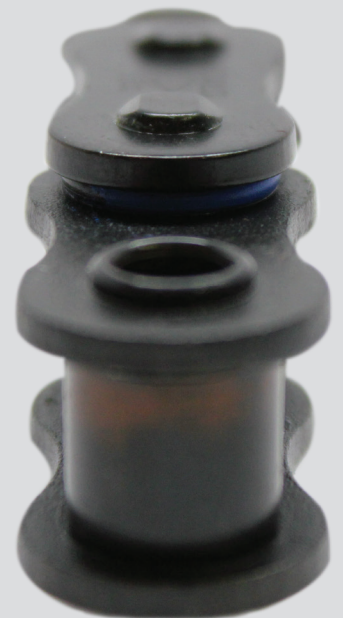
To solve the issue, Diamond Chain recommended its O-Ring chain. O-Ring chain is one of Diamond's reduced maintenance product offerings and is constructed with polymer o-rings that seal a specially formulated lubricant into every joint while sealing out contaminants such as dirt and moisture, thus extending the life of the chain. While regular lubrication of the pin/bushing joint is not required with the Diamond O-Ring chain, the use of supplemental lubrication on the o-ring can extend the life of the chain even further.
